Water pump leaks, shows signs of calcium/rust

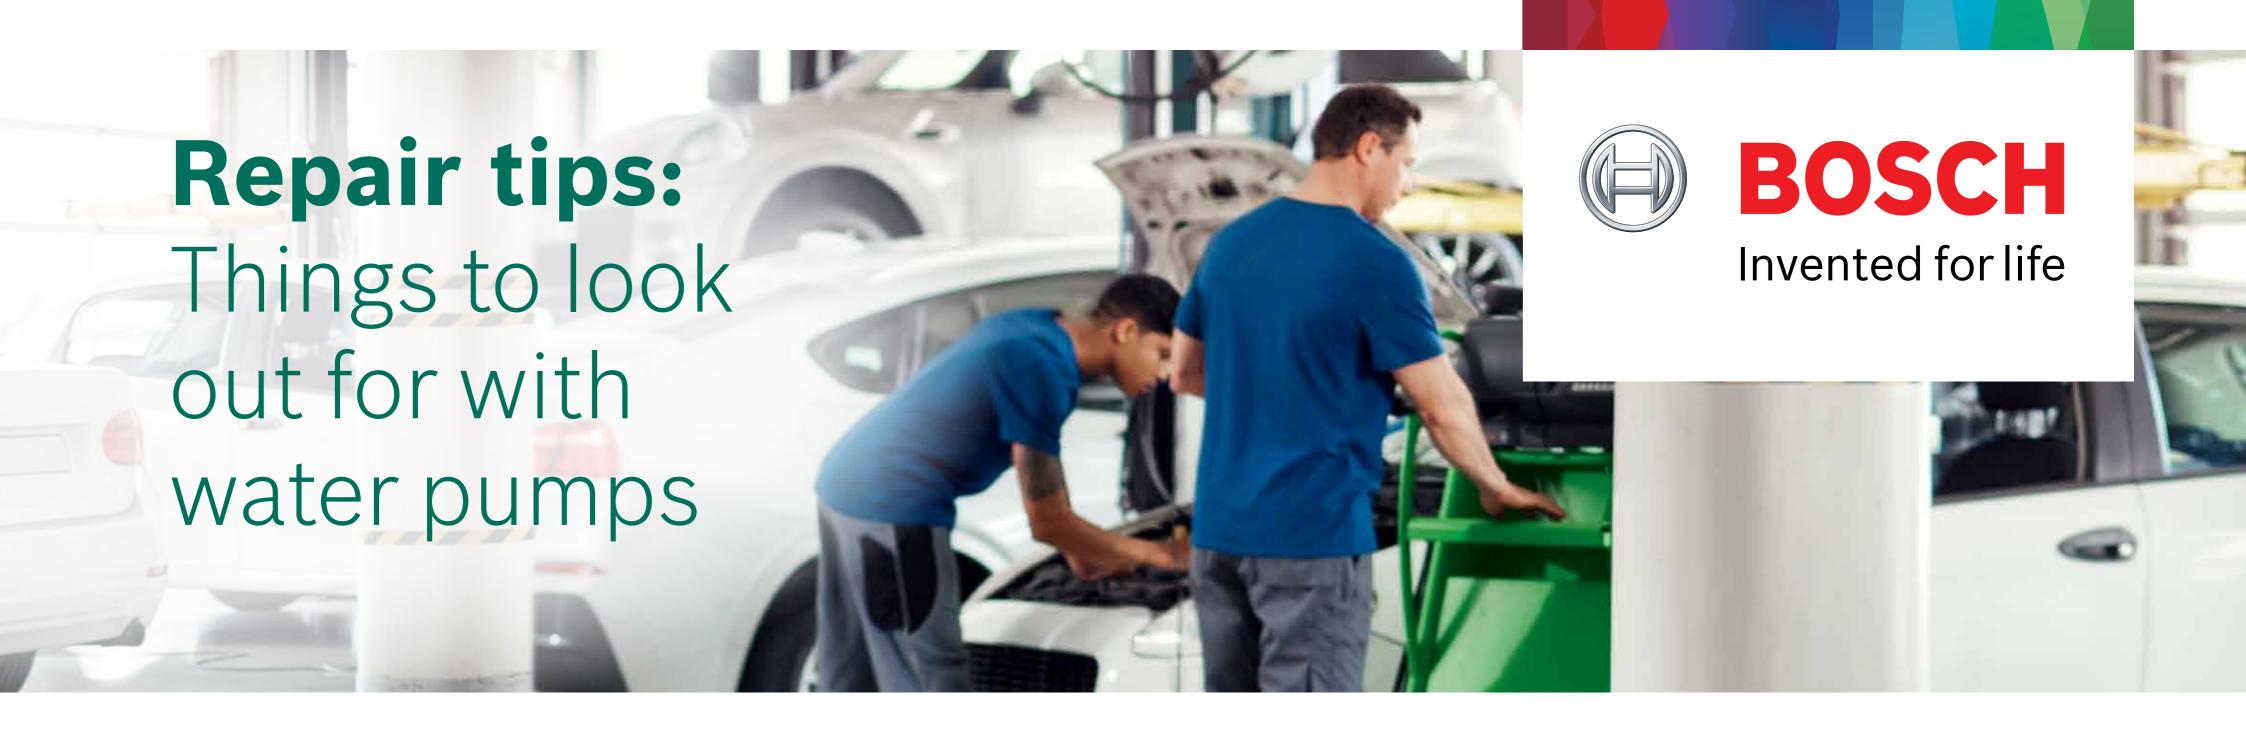
Cause

Water with a high mineral content is added to the system, over a period of time

Effect

- ► Formation of deposits
- ► Restrictions to the flow of the coolant
- ► Damage of the seal of the pump

Recommendation

- ► Clean the cooling system before replacing a new waterpump
- ► Check system pressure, use correct coolant
- mixture ► Never use tap water
